Roofing Report: <Address>

1. Scope of Reporting

The purpose of this report is to provide feedback on the overall condition of all roofing areas at [REDACTED] Location: [REDACTED]

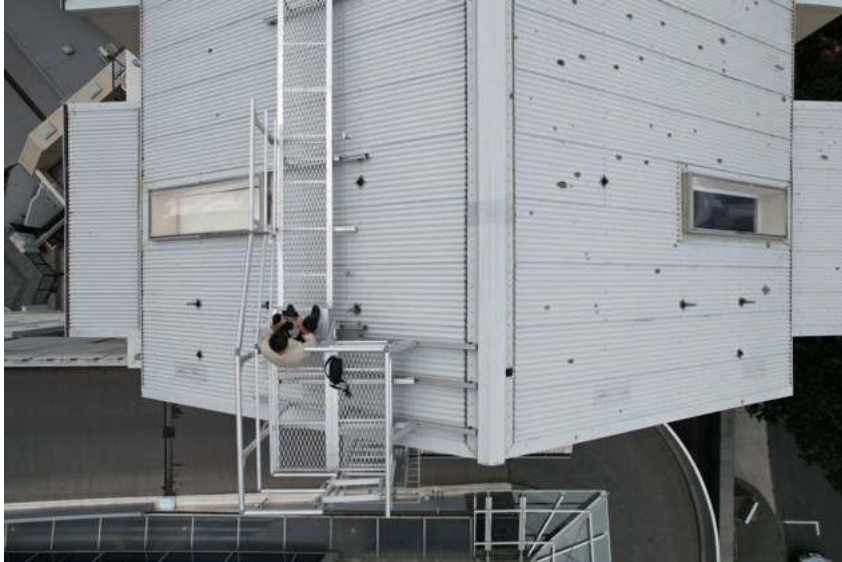
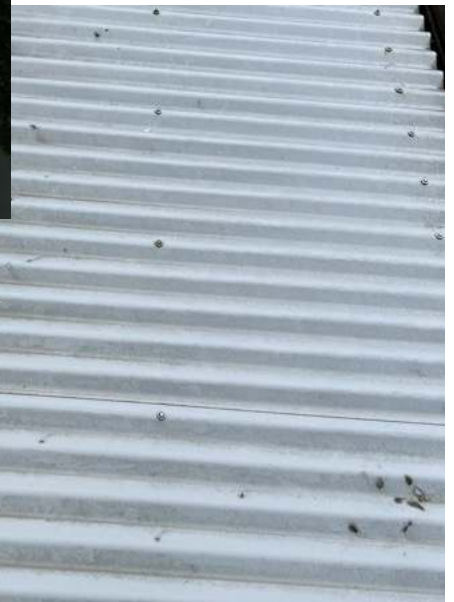
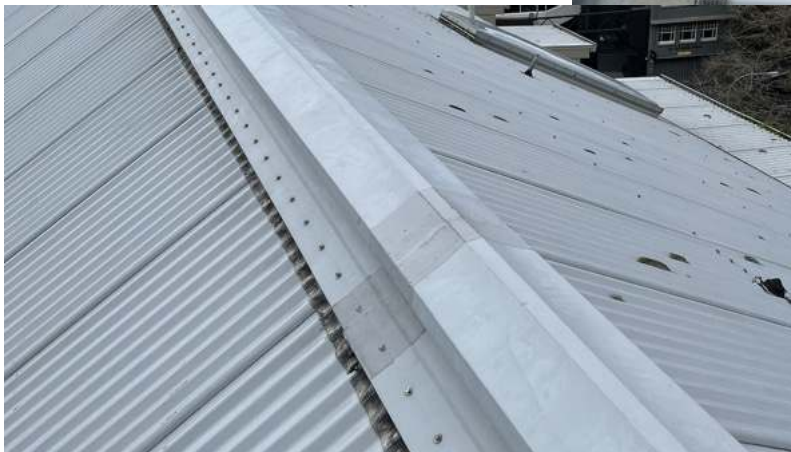
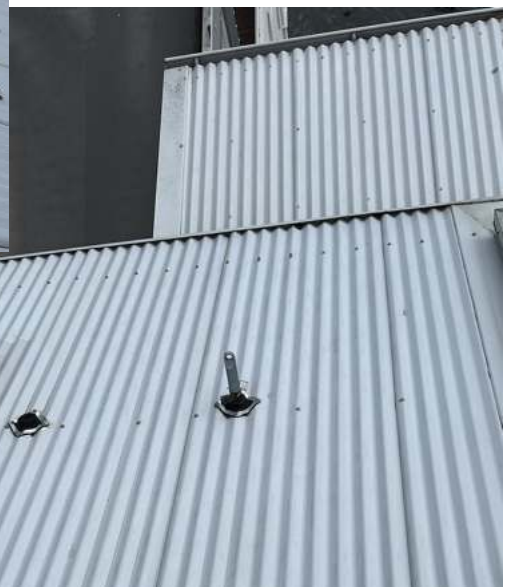
South Side

General Feedback: This roofing area is in fair condition, was installed correctly and has no obvious waterproofing issues. There are certainly defects in the initial installation. There are a number of fiberglass patches over particular weak points, presumably installed to address water ingress issues. There are many large penetrations and skylights that, according to E2 standards, should have back-tray flashings to avoid water build up.

There is significant lichen build up on many roofing areas, this should be addressed immediately to avoid further degradation in the roofing material as a result.

Internal guttering is showing wear and tear and significant surface rust. External guttering is in fair condition but needs to be cleaned to ensure water clears effectively.

Aesthetic Feedback: This roof generally looks in fair condition for its age. There are many fiberglass patches that negatively affect the aesthetic and lichen is prolific; this gives the roof a poorer appearance than its underlying quality necessitates.

The screw heads and saddles have tiny surface rust but this is normal and purely aesthetic. There is a small amount of rust on the edges of the sheets (lateral laps) and some flashings but this is normal for a roof this age.

Recommendation: Chemical treatment & Roof cleaning / lichen removal

- **Recommended action:** Full chemical clean of entire roofing area, tradesmen to utilise a fall arrest system to execute as to avoid a scaffolding requirement.
- **Estimated costings:**
 - \$4,000 waterblasting, chemical clean of all roofing areas via full fall arrest / abseiling system.
 - \$4,000 + GST Total
- **Timeframe recommendation:** ASAP and again in 5 years time.
