Roofing Report: <Address>

1. Scope of Reporting

The purpose of this report is to provide feedback on the overall condition of all roofing areas at [REDACTED] Location: [REDACTED]

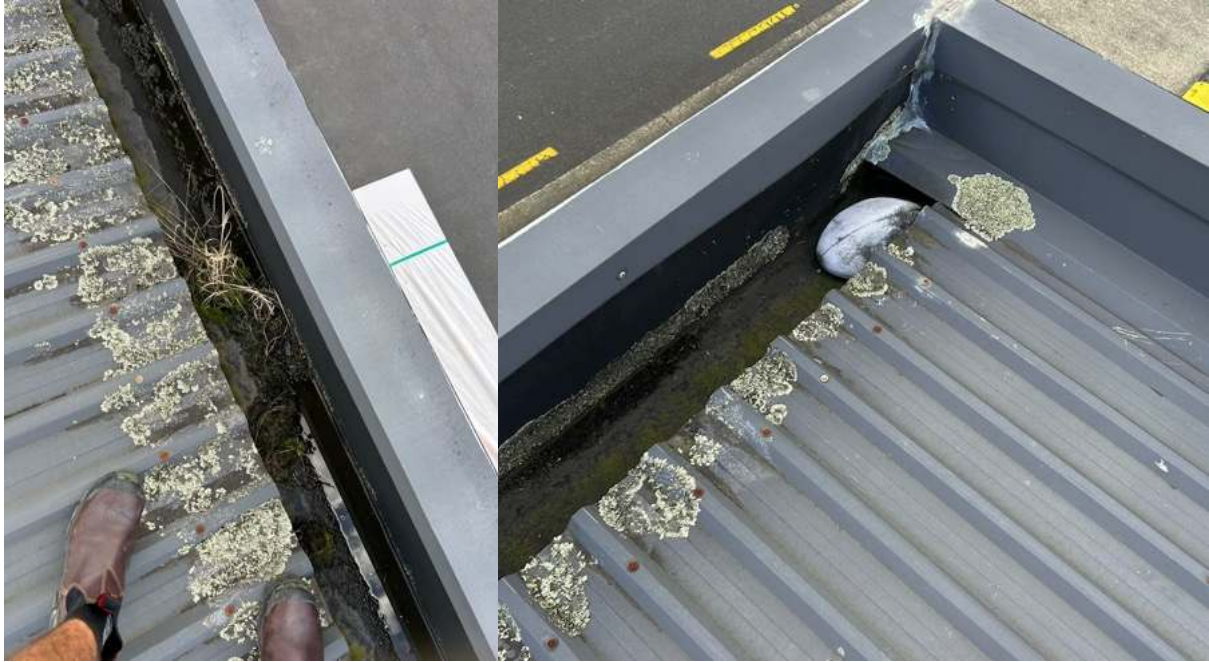
Gutter & Screws

Internal guttering is showing wear and tear and significant surface rust. External guttering is in fair condition but needs to be cleaned to ensure water clears effectively.

The screw heads and saddles have tiny surface rust but this is normal and purely aesthetic. There is a small amount of rust on the edges of the sheets (lateral laps) and some flashings but this is normal for a roof this age.

There are other remedial and longevity actions that are theoretically possible but due to the challenging access requirements for this building they are not cost effective. Re-coat / paint and rebedding the rusty internal gutter would be great steps to take to increase the longevity of the roofing however the scaffolding requirement and cost; this should be left aside until the roof is full degraded and a replacement is required. The owners should consider a full exterior cladding maintenance / painting be undertaken concurrently with the re-roofing in 10+ years making use of large scaffolding investment and infrastructure required to do the reroofing.

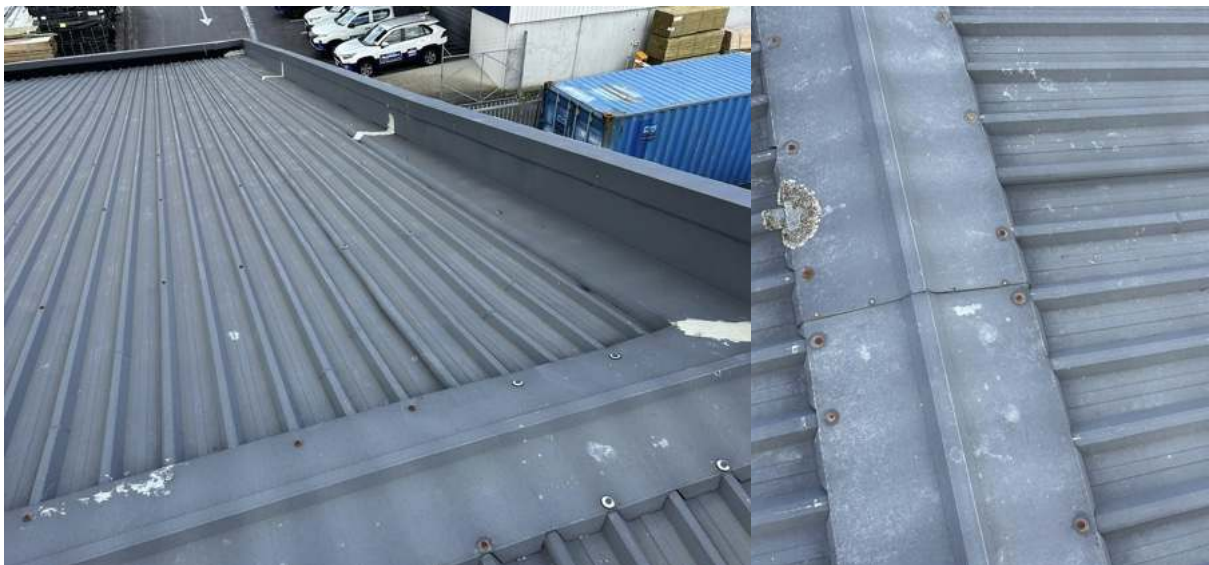
Ridge & Parapet

Some of the detailing on the flashing work while waterproof could have been installed more tidily; however this is standard practice for commercial roofing and the roof is not visible from street level the negative impact of these aesthetic downsides could be largely discounted.

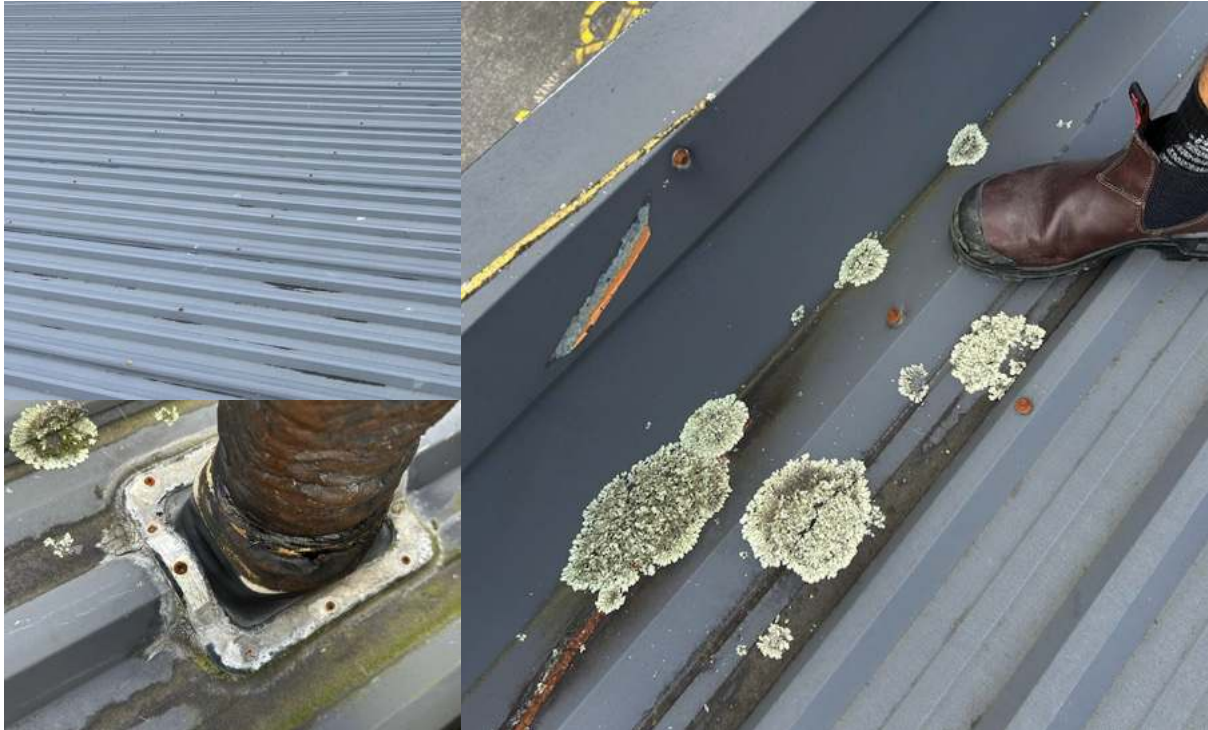
General Feedback: This roofing area is in fair condition, was installed correctly and has no obvious waterproofing issues. There are certainly defects in the initial installation. There are a number of fiberglass patches over particular weak points, presumably installed to address water ingress issues. There are many large penetrations and skylights that, according to E2 standards, should have back-tray flashings to avoid water build up.

There is significant lichen build up on many roofing areas, this should be addressed immediately to avoid further degradation in the roofing material as a result.

Aesthetic Feedback: This roof generally looks in fair condition for its age. There are many fiberglass patches that negatively affect the aesthetic and lichen is prolific; this gives the roof a poorer appearance than its underlying quality necessitates.

Recommendation: Chemical treatment & Roof cleaning / lichen removal

- **Recommended action:** Full chemical clean of entire roofing area, tradesmen to utilise a fall arrest system to execute as to avoid a scaffolding requirement.
- **Estimated costings:**
 - \$4,000 waterblasting, chemical clean of all roofing areas via full fall arrest / abseiling system.
 - \$4,000 + GST Total
- **Timeframe recommendation:** ASAP and again in 5 years time.
