Roofing Report: <Address>

1. Scope of Reporting

The purpose of this report is to provide feedback on the overall condition of all roofing areas at [REDACTED] Location: [REDACTED]

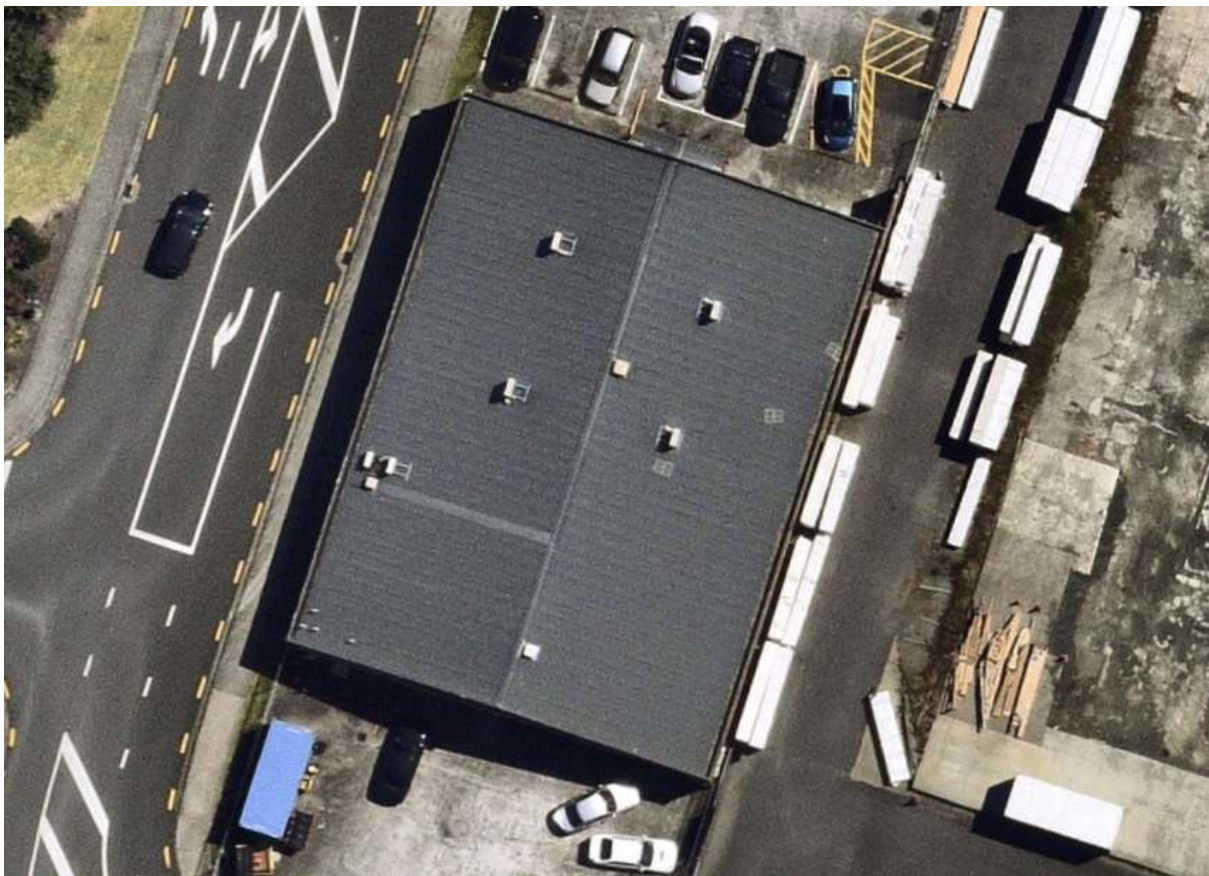
Overhead image (raw)

Given the size of the building and the similarity in the condition, type and age of roofing materials we have reviewed all roofing areas at this address in one detailed scope. The analysis and recommendations are made specific to requirements and over all roofing areas at the address.
